# Manhole Inspection Summary

Manhole # S1900\_021MH

Insp Date: **12/16/08 12:20 PM**

**Location** Address: **2325 REISTERSTOWN RD**

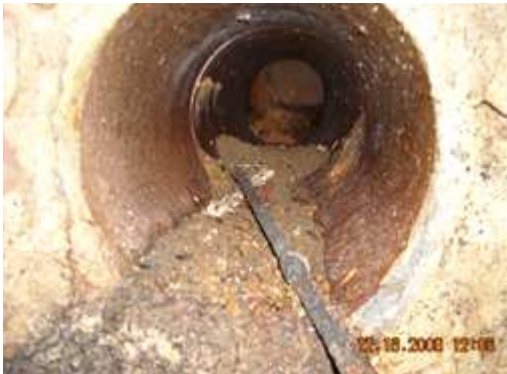
view in drop connection

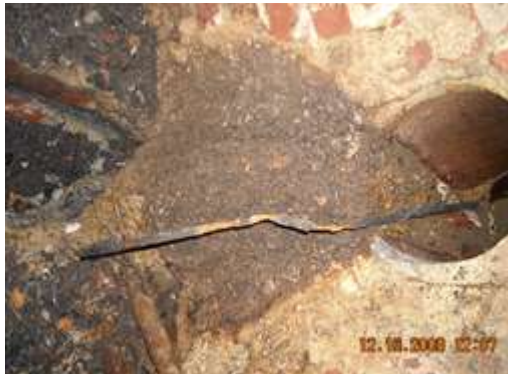
pipe in and drop @ 4 O'Clock

this picture better shows condition of inside drop

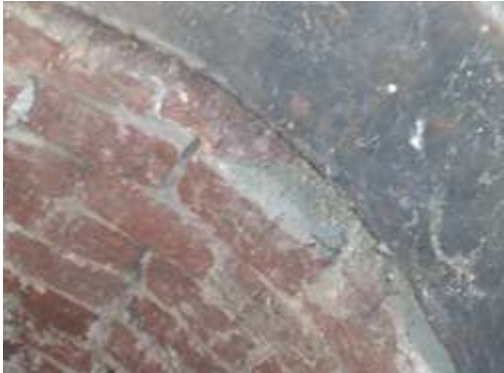
Defect 2

Condition: ☐ Sound ☐ Cracked ☐ Root Intrusion ☐ Loose Brick ☒ **Deteriorated**

DETERIORATION OF CORBEL

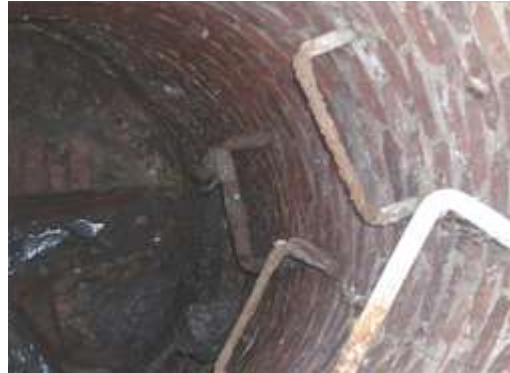
Defect 1

Count: **8** Missing: **0** ☒ **Corroded**

(ft.) ☒ **Active Surcharge Present**

CORRODED STEPS AND SURCHARGE EVIDENCE

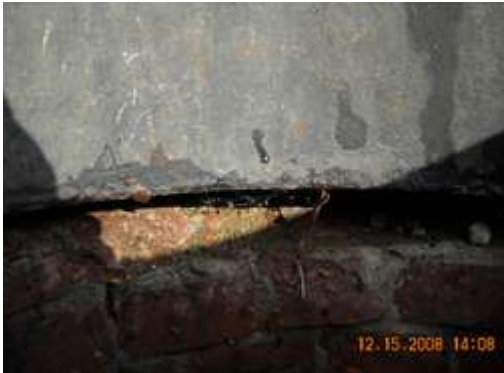
Defect 3

BRICKS MISSING BELOW FRAME

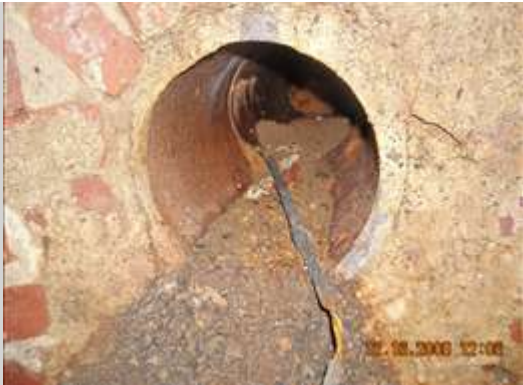
Drop In @ 4 O'Clock

believe connection is capped

Drop: <b>Inside</b>	Rod and Bar
Angled: <b>Yes</b>	Reading: <b>11.30</b> (ft.)
	Inv Depth: <b>12.30</b> (ft.)
Drop Condition: <b>Partly Clogged</b>
